U.S. DEPT. OF THE INTERIOR
OFFICE OF SURFACE MINING
Mine Site Evaluation
State Program

Mine Name: Crandall Canyon Mine

Permit ID #: C/015/0032

Inspection Date: April 3, 2012 10:00 – 12:30

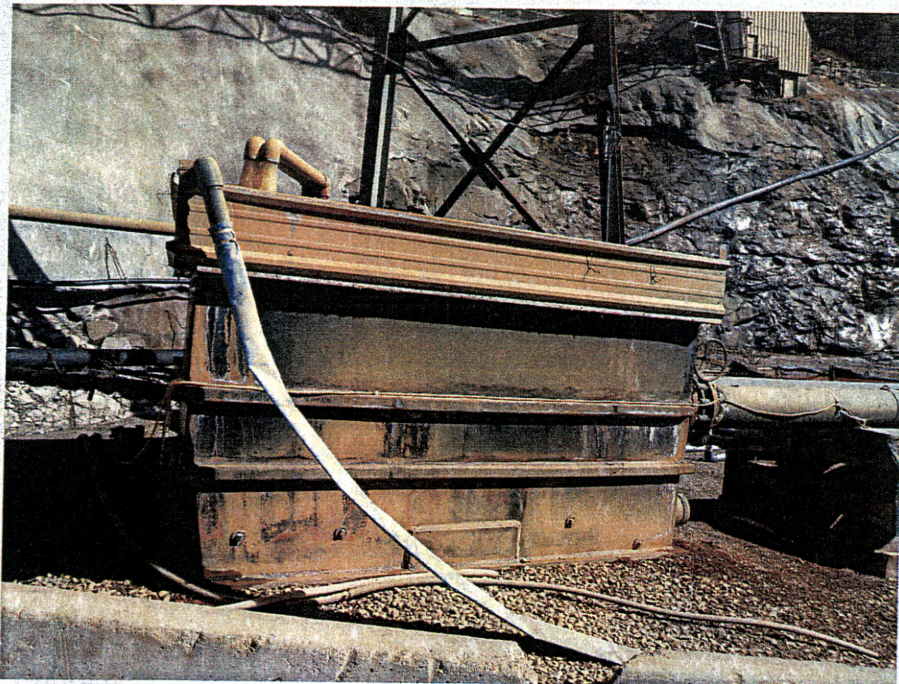
Photo ID: 6784

Subject: MAELSTROM UNIT AERATOR

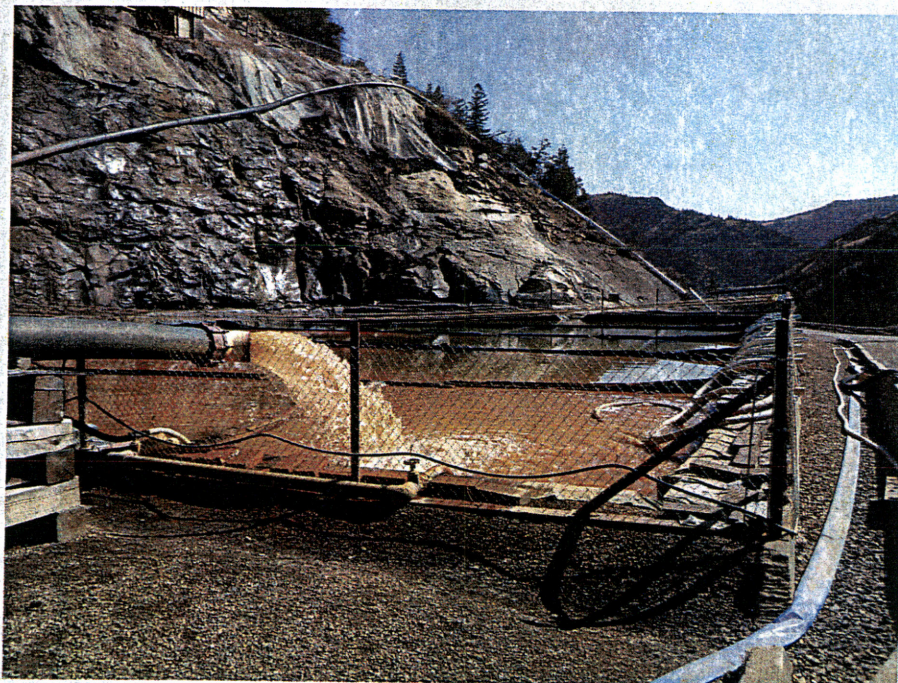
Photo ID: 6785

Subject: WATER TREATMENT FACILITY

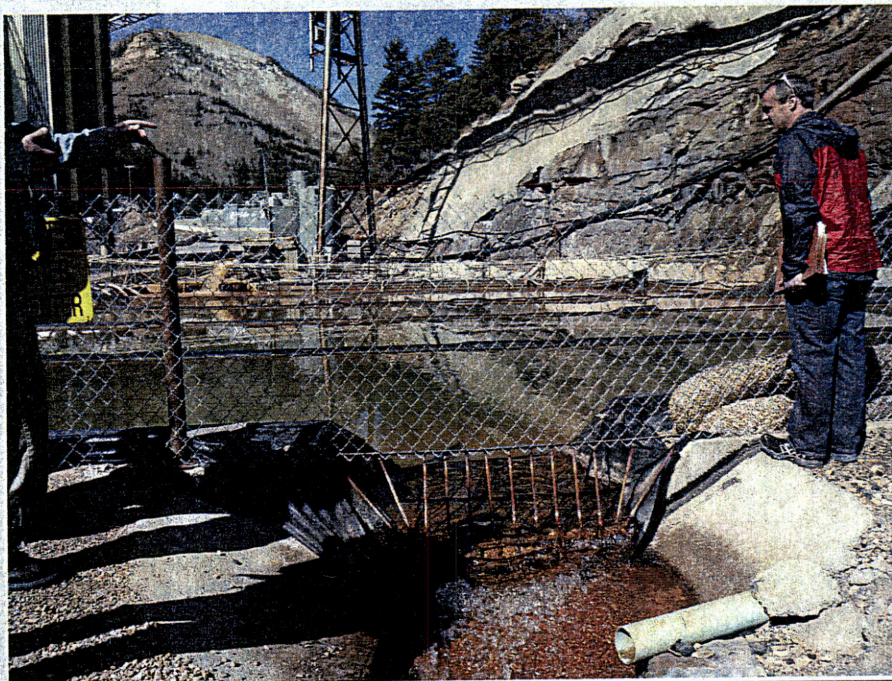
Photo ID: 6786

Subject: IRON STAINING AT TREATMENT SYSTEM OUTFALL

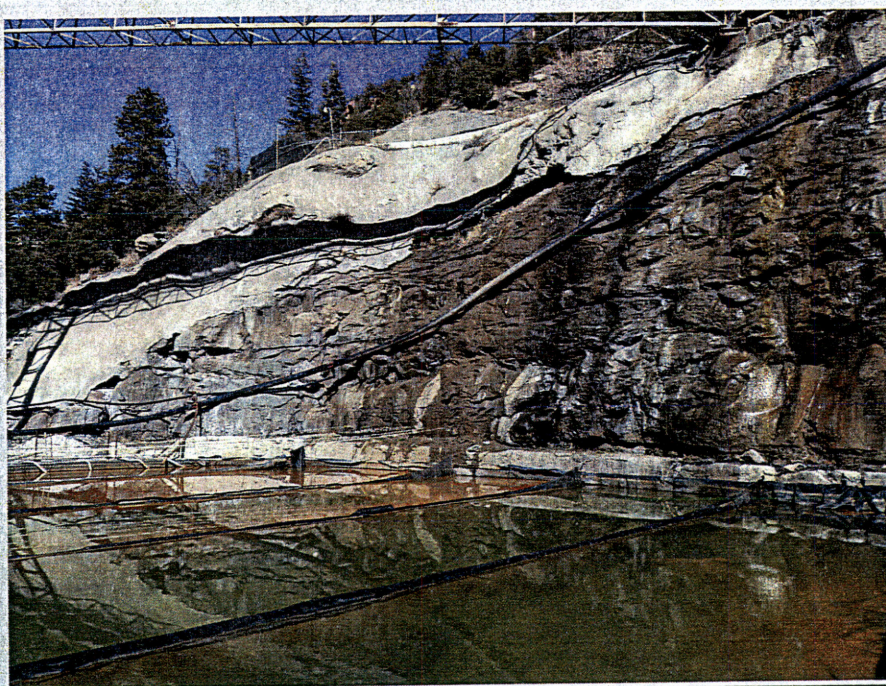
Photo ID: 6787

Genwal applied shotcrete to the highwall where several small seeps exist. The seeps are destabilizing the shotcrete and large pieces are sloughing off into the impoundment. The shotcrete remaining on the highwall presents a safety hazard, as it is likely to fall down in the vicinity of the impoundment (see photo 6787). This could harm persons below or compromise the integrity of the impoundment.

Seeps along the highwall compromise the shotcrete, which is falling into the water treatment structure.

Subject: SHOTCRETE ON HIGHWALL CREATES SAFETY HAZARD BELOW

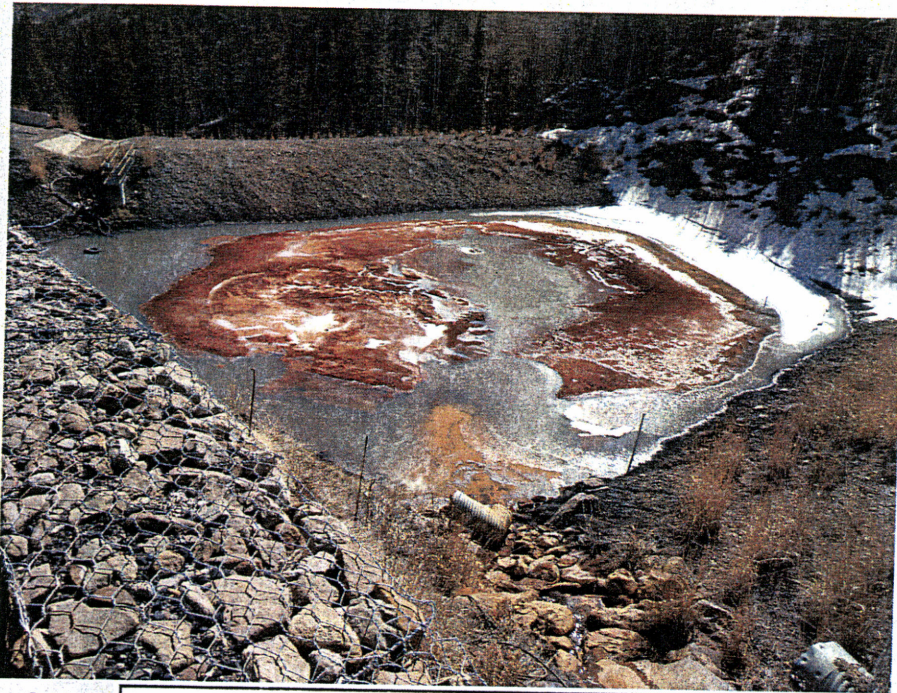
Photo ID: 6788

Genwal recently submitted a permit revision to DOGM which proposed a plan to dry and dispose of the precipitated iron sludge. The charged iron particles do not form a cohesive mass that could be removed or disposed of easily. Genwal vacuums the sludge from the impoundment, which reportedly yields a waste product that is approximately 90 – 95% water. Iron would not be classified as a hazardous waste,

but the local landfill does not accept fluidized waste. Iron precipitate is currently stored in the primary sedimentation pond (see photo 6788). This pond is nearing its sediment storage capacity and will likely require clean-out this year. DOGM has not yet finished its review of the revision application.

Genwal does not yet have an approved method for disposing of iron sludge.

Subject: SEDIMENT POND NEAR CLEANOUT LEVEL

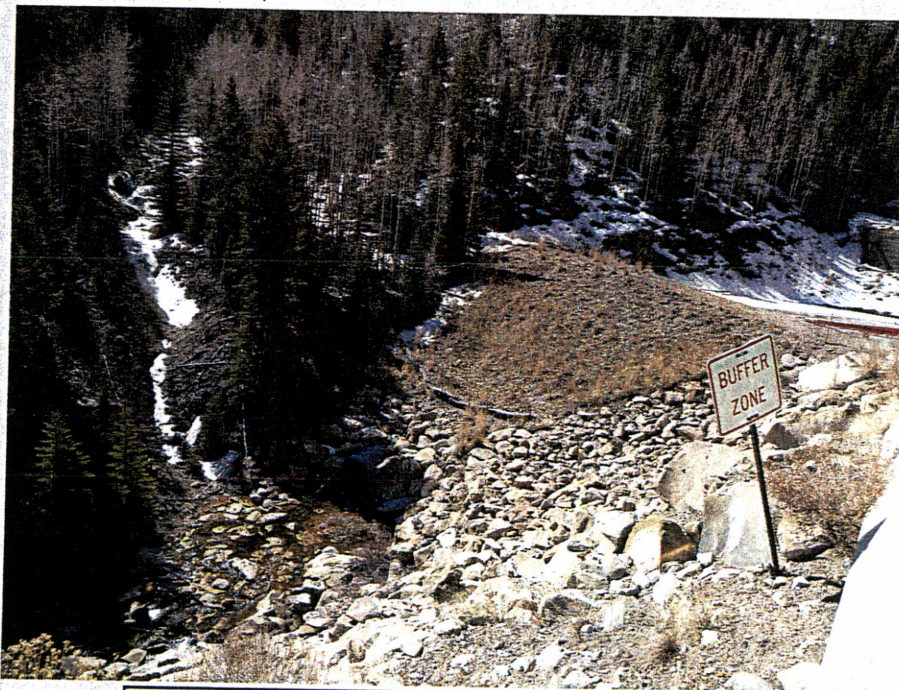
Photo ID: 6789

Remnants of historic iron staining evident, no recent staining noted. Fish were observed in the creek immediately below this location.

Subject: CRANDALL CREEK AT OUTFALL LOCATION
